Exhibit E – Environmental Report

Rocky Mountain Pumped Storage Hydroelectric Project

FERC No. 2725

Application for New License for Major
Water Power Project >5MW

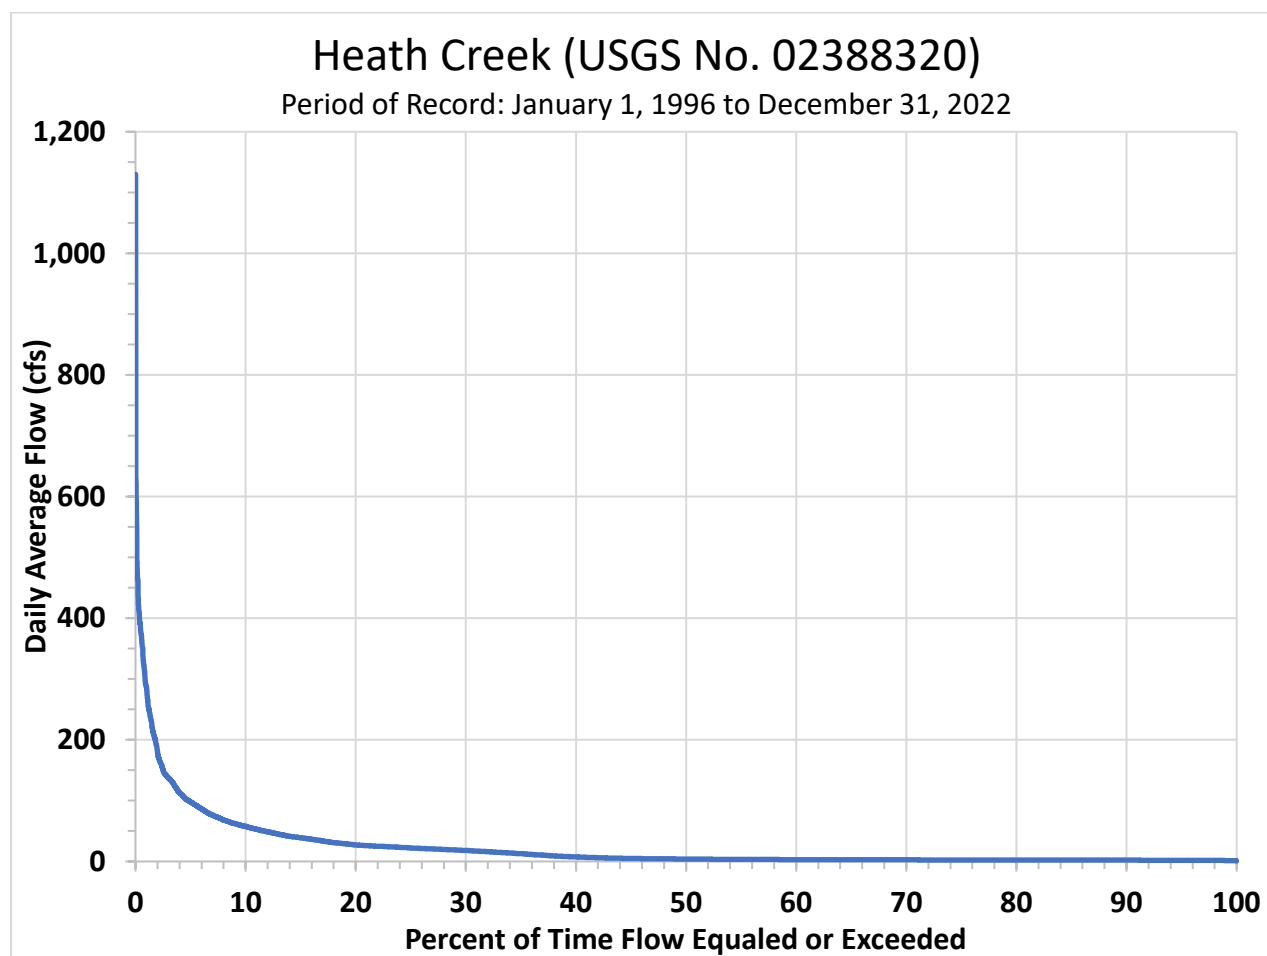
Figure 4 Annual Flow Duration Curve for Heath Creek

Monthly minimum, average, and maximum flows at this gage for the 27-year period of record (1996-2022) are listed for each month in Table 5. Average monthly flows ranged from a low of 4.4 cfs in August to a high of 49.2 cfs in March. The minimum flows usually occurred in mid to late summer and high flows tended to occur in winter and early spring, excluding the extreme high-flow event in September 2022.

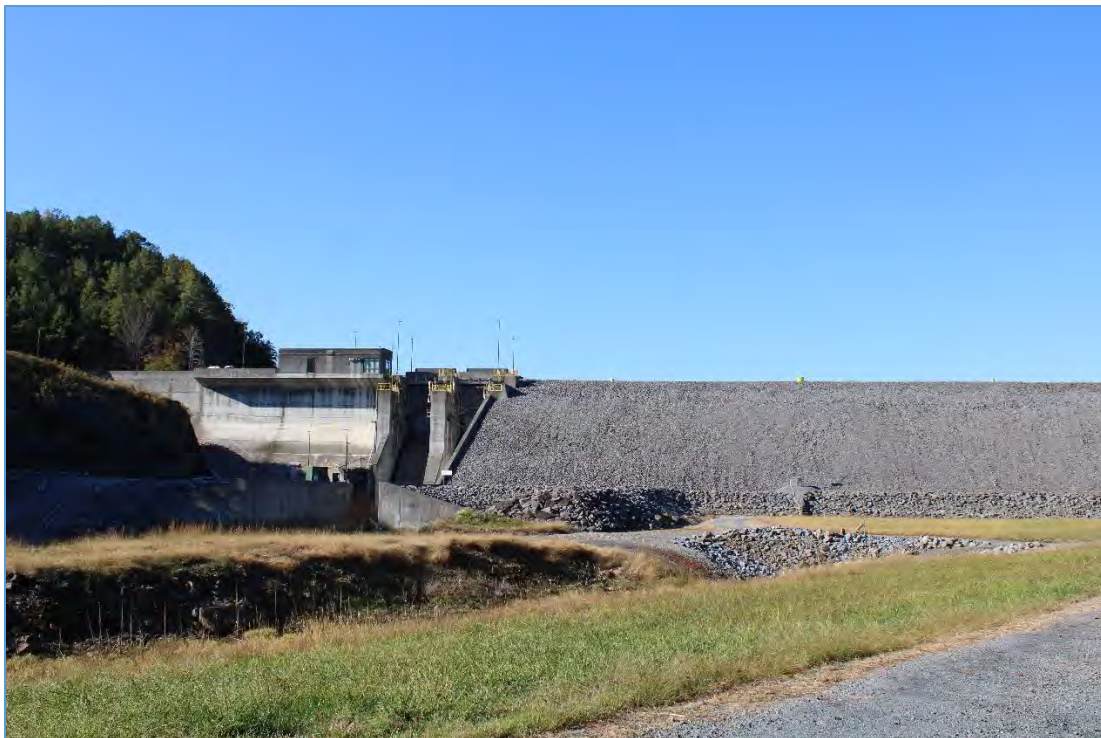
Figure 46: View of the Main Dam, control building, spillway, and flume looking southwest.

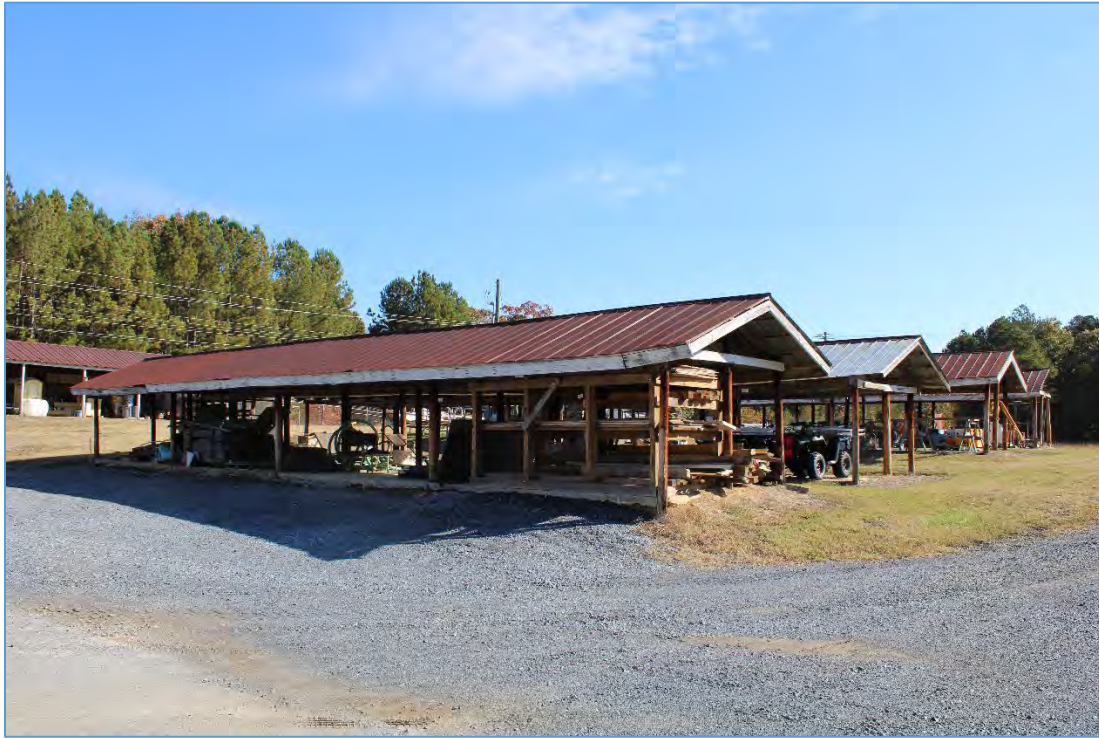
There are four frame storage sheds located centrally between the three main buildings (Figure 83). Of frame construction, each open bay shed has a gable roof clad in metal and rests on a poured concrete slab foundation.

Figure 83: Open storage sheds east of Building One and south of Building Two, looking northeast.

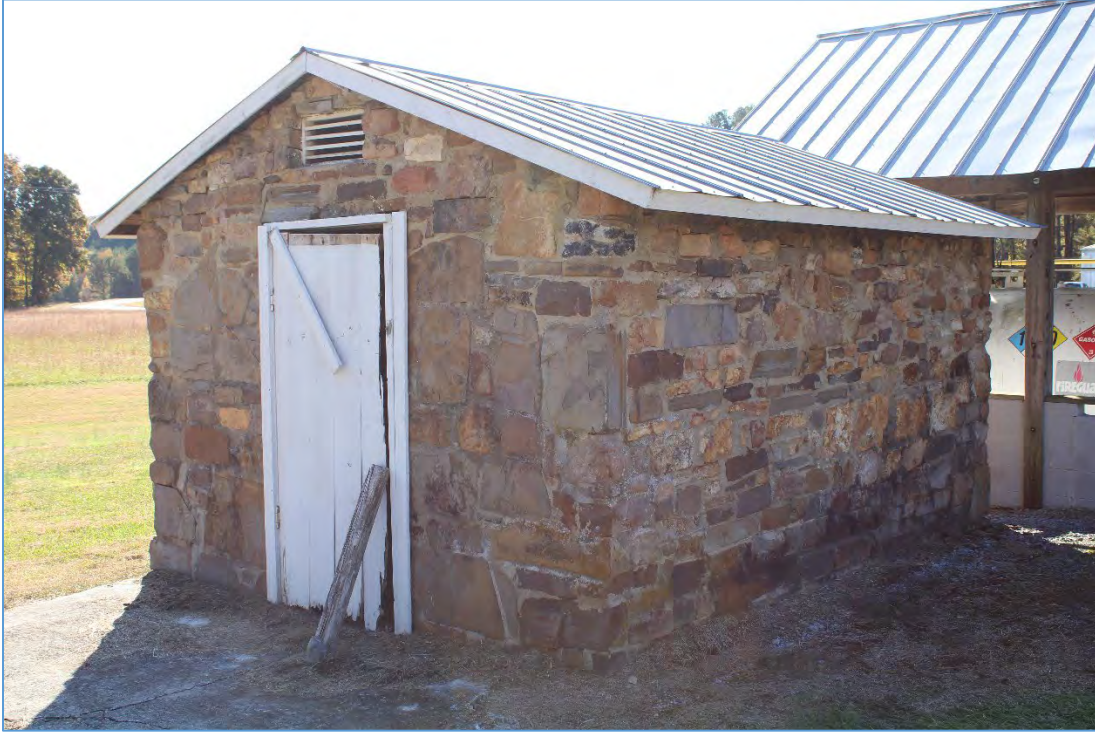
Adjacent to the open bay sheds is a vacant, one-room stone building (Figure 84). Oriented north, the building has a replacement gabled roof clad in metal. The façade features a vertical wood plank door; the south elevation is pierced by a replacement stationary four-light vinyl sash window. The door was nailed shut and access was not possible at the time of the survey.

Figure 84: North façade of vacant stone building, looking southeast.

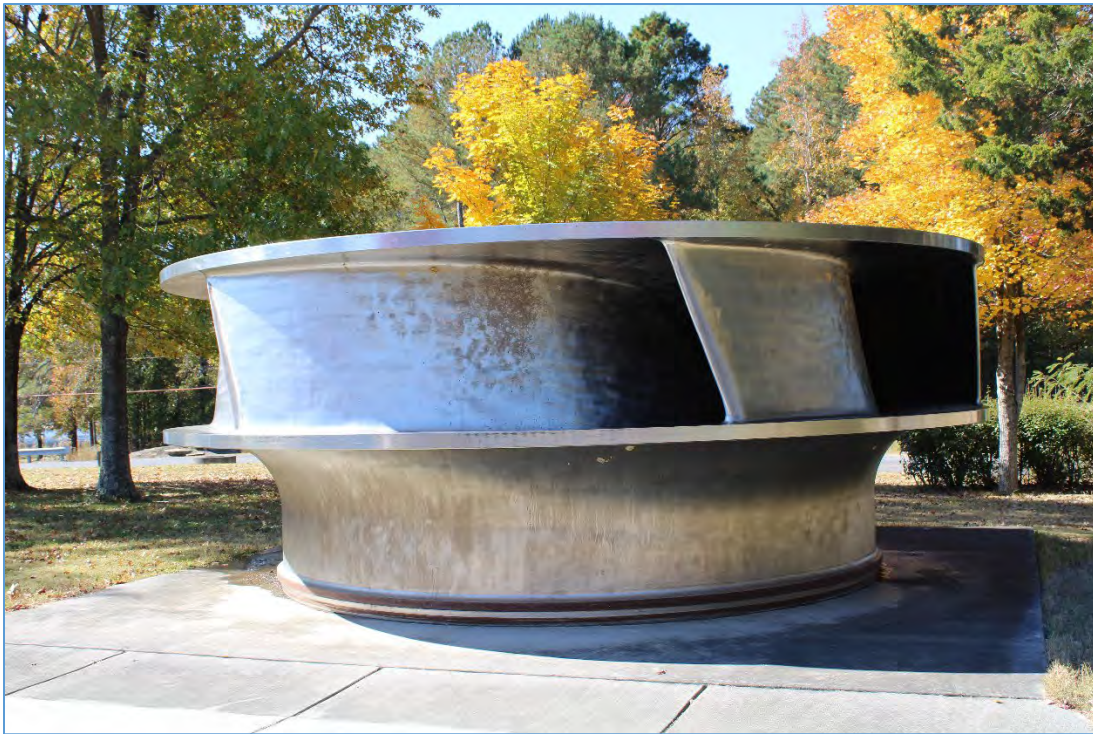
Figure 100: Francis-type reversible pump-turbine impeller located at the Visitor Center, looking west.
